ADR 13/00 AND IN-SERVICE VEHICLE STANDARDS TAIL/STOP/INDICATOR LIGHT CONFIGURATIONS

AUSTRALIAN TRUCKING ASSOCIATION TECHNICAL SUBMISSION 10 MAY 2018

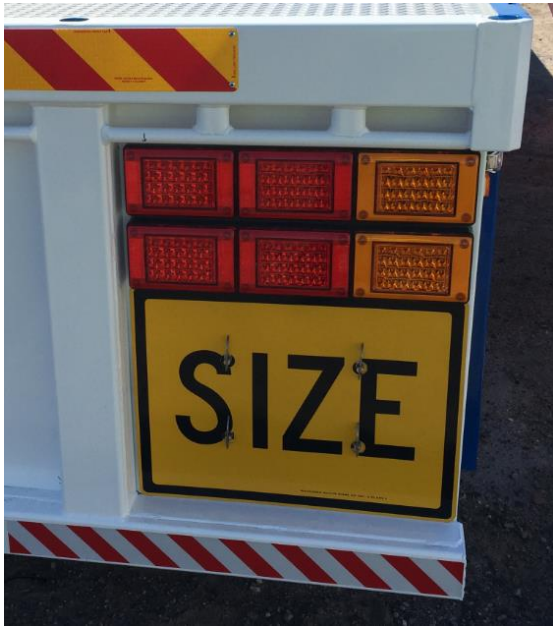
Figure 1:

Two (2) x each ADR compliant - Jumbo Triple Module Stop/Tail/Rear Direction Indicator Lamp assemblies in combination. Functions aligned vertically and therefore **considered to be appropriately grouped and roadworthy.**

Multiple installations of lights (as per figure 1) are common. These should be accepted by roadside enforcement.

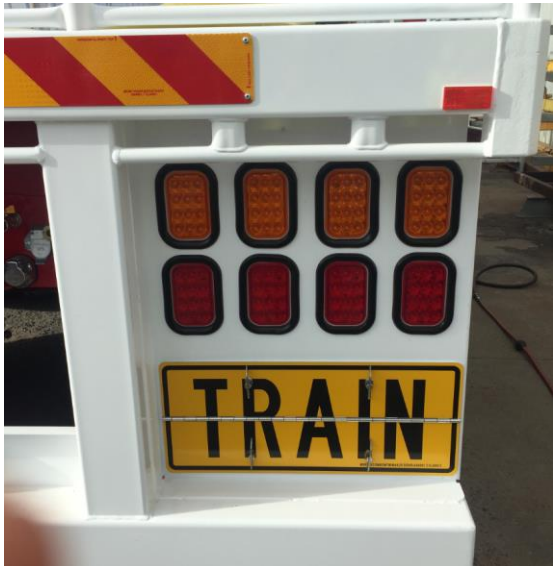
Figure 3:

Four (4) x Indicator and four (4) x stop/tail combinations – each ADR complaint. Turn indicator function/s horizontally aligned; and, stop/tail functions horizontally aligned; and therefore, **considered to be appropriately grouped and roadworthy.**

Multiple installations of individual tail/stop and rear mounted indicators as shown in figures 3 and 4 provide a clear delineation of the tail/stop and indicator function and should be specified as acceptable.

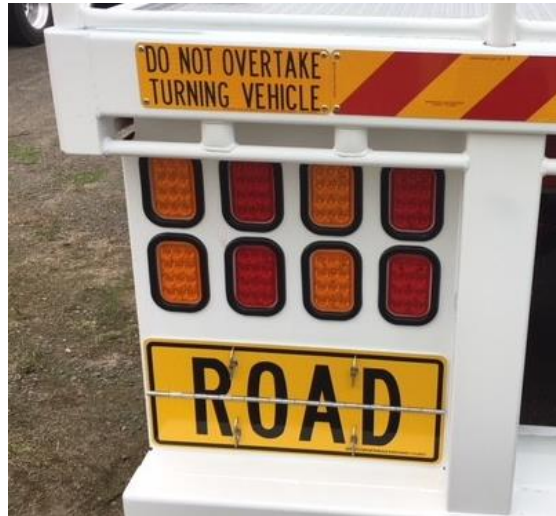
Figure 2:

Four (4) x Indicator and four (4) x stop/tail combinations – each ADR compliant. Functions not consistently aligned vertically or horizontally therefore considered **NOT** to be appropriately grouped and **should be discouraged.**

Multiple installations of individual tail/stop and rear mounted indicators as shown in figure 2 are less than desirable and should be discouraged.

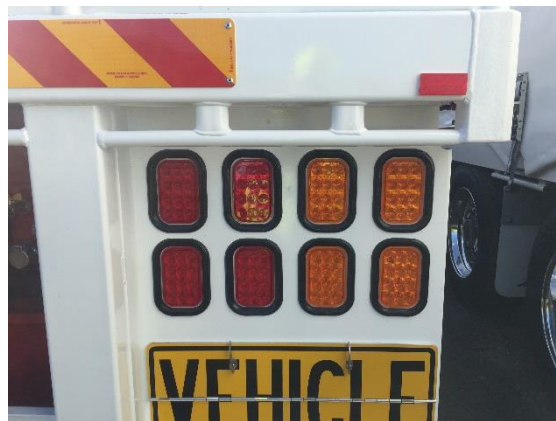
Figure 4:

Four (4) x Indicator and four (4) x stop/tail combinations – each ADR complaint. Turn indicator function/s grouped to right; and, stop/tail functions grouped inboard; and therefore, **considered to be appropriately grouped and roadworthy.**
