# Safety alert

## Long stroke brake chambers and brake balance

**SA # 2015-4**

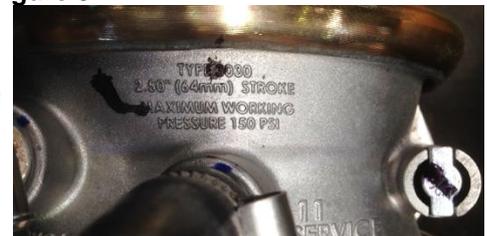
Figure 3

- Trapezoidal shaped tag with the stroke information detailed (figure 1)
- Square boss around the chamber's air supply port or ports (figure 2)
- Embossed or cast-in service instruction advising chamber details (figure 3)

Ensure components are identical across an axle and, optimally, within an axle group.

- Safety related replacement parts should be either original or certified as being equivalent to original parts
- Identical parts must be used across an axle and, optimally, within an axle group
- Ensure parts and workshop staff can identify long stroke brake chambers.
